MARYLAND INVENTORY OF HISTORIC BRIDGES
HISTORIC BRIDGE INVENTORY
MARYLAND STATE HIGHWAY ADMINISTRATION/
MARYLAND HISTORICAL TRUST

MHT No. <u>CAR-301</u>

SHA Bridge No. CO-20 Bridge name <u>Tuckahoe Road over Tributary of Tuckahoe Creek</u>
LOCATION: Street/Road name and number [facility carried] Tuckahoe Road
City/town Hillsboro Vicinity X
County Caroline
This bridge projects over: Road Railway Water X Land
Ownership: State County X Municipal Other
HISTORIC STATUS: Is the bridge located within a designated historic district? Yes No National Register-listed district National Register-determined-eligible district Locally-designated district Other
Name of district
BRIDGE TYPE: Timber Bridge: Beam Bridge: Truss -Covered Trestle Timber-And-Concrete Stone Arch Bridge Metal Truss Bridge
Movable Bridge: Swing Bascule Single Leaf Bascule Multiple Leaf Vertical Lift Retractile Pontoon
Metal Girder: Rolled Girder: Plate Girder: Plate Girder Concrete Encased Plate Girder Concrete Encased
Metal Suspension
Metal Arch
Metal Cantilever
Concrete X: Concrete Arch X Concrete Slab Concrete Beam Rigid Frame Other Type Name

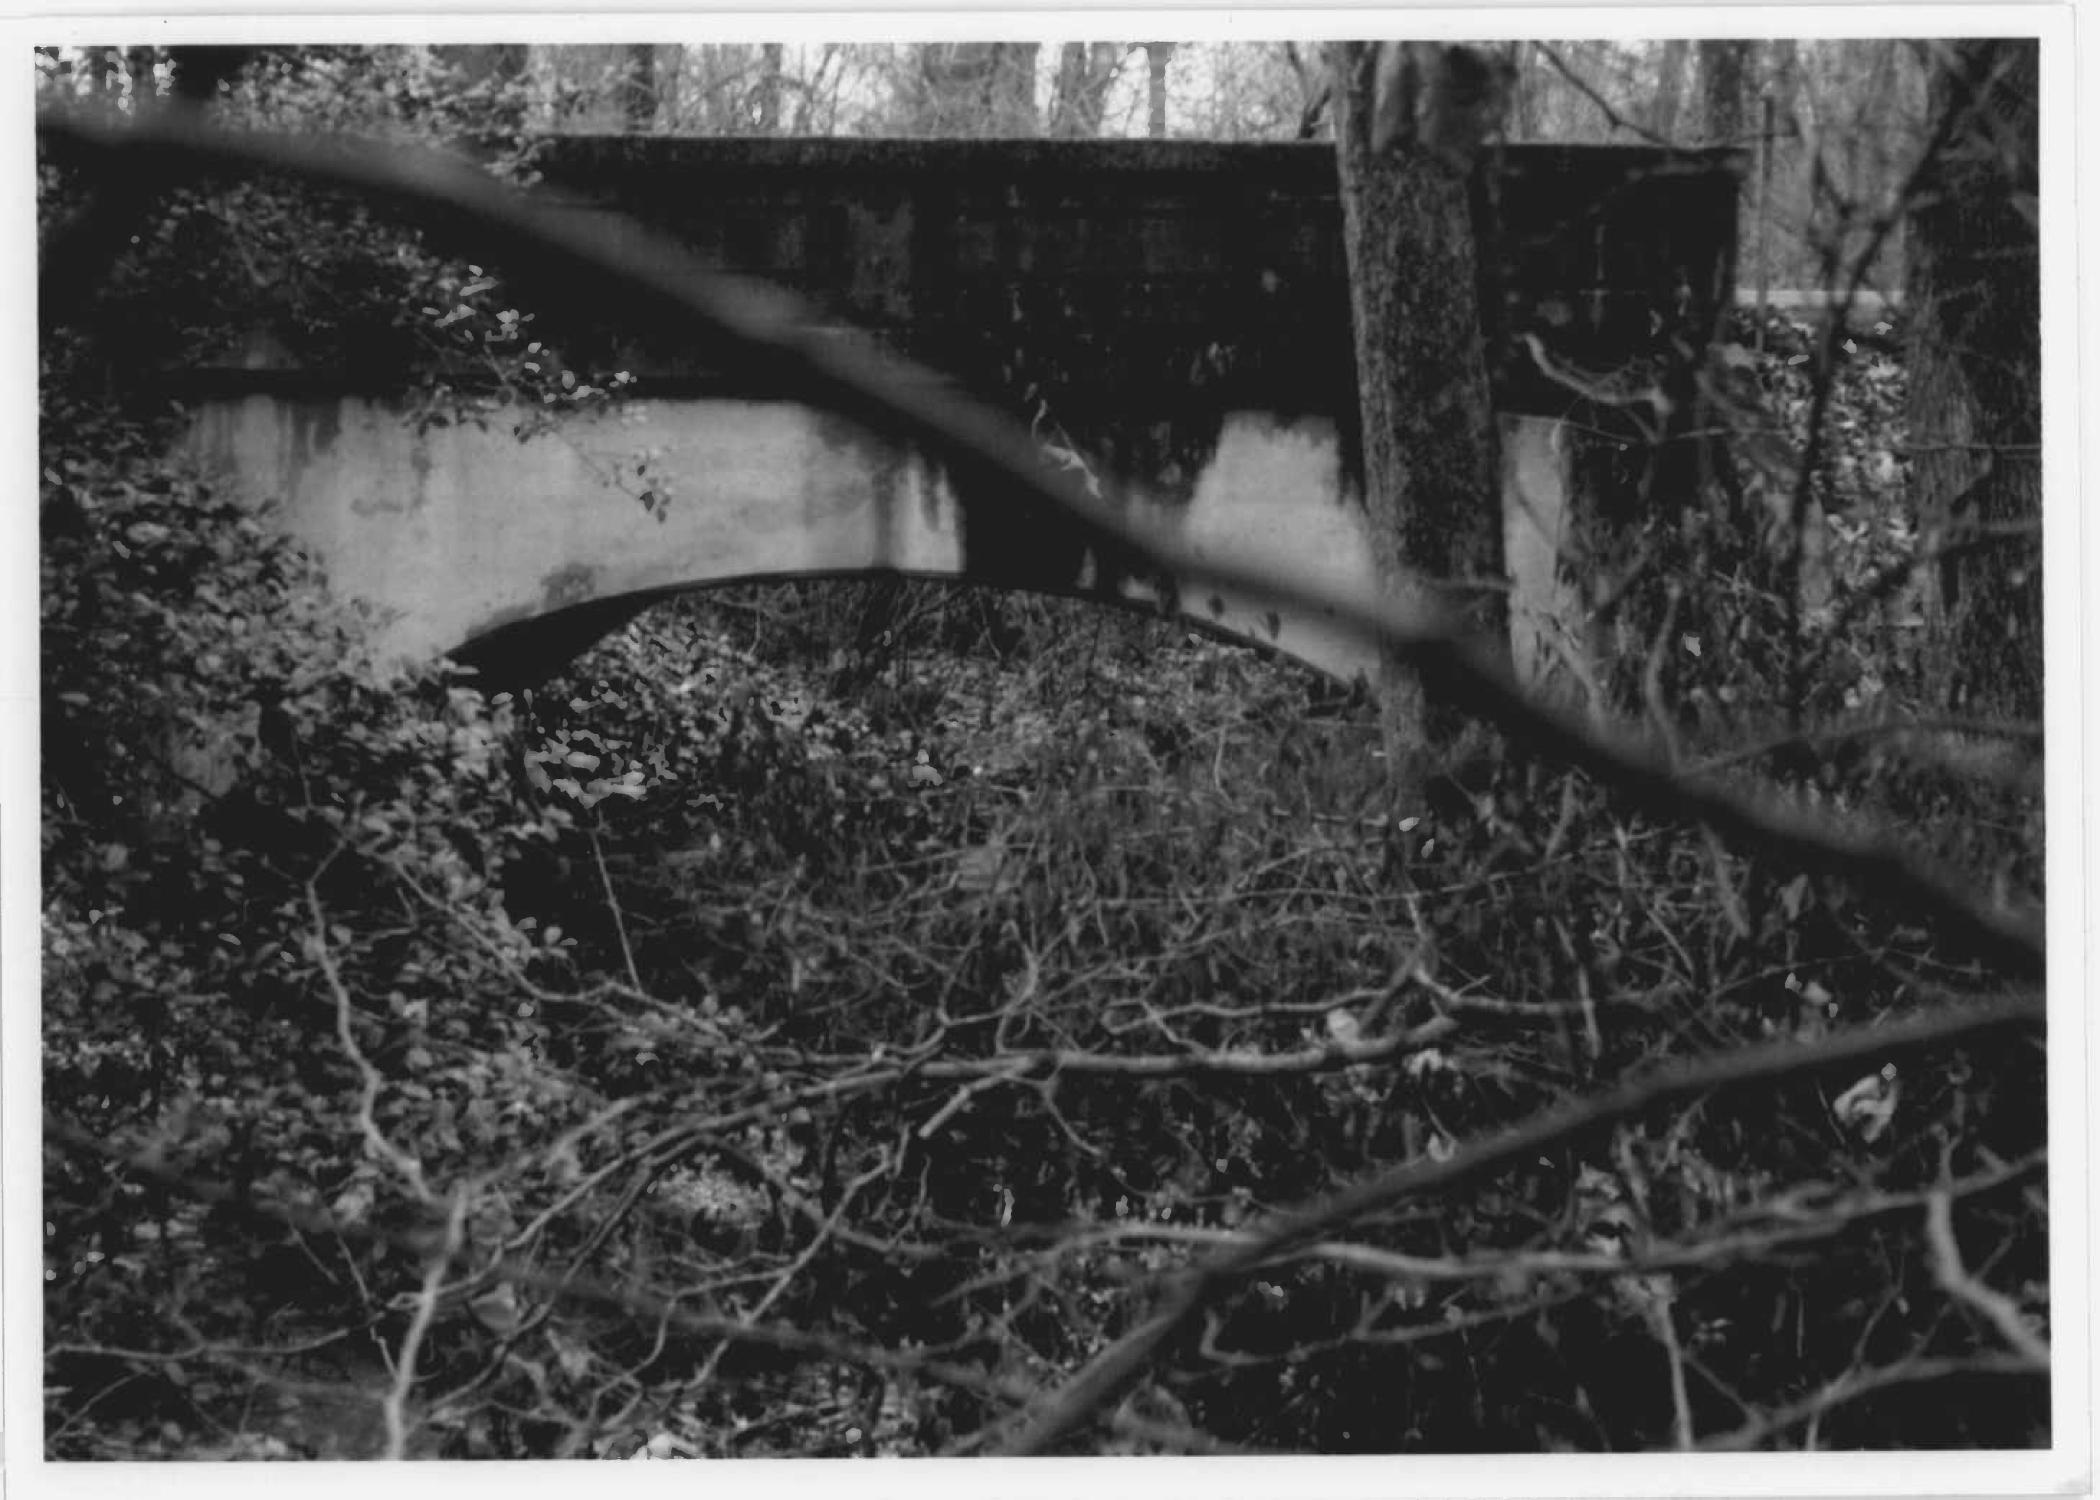
- 1. CAR-301
- 2. COZO, TUCKAHOE ROAD OVER TRIBUTARY TO TUCKAHOE CREEK
- 3. CAKOLINE COUNTY
- 4. WALLACE, MONTGOMERY & ASSOC.
- 5, 12/97
- 6. MD SHPO
- T. ELEVATION LOOKING UPSTREAM
- 8.1 OF 4

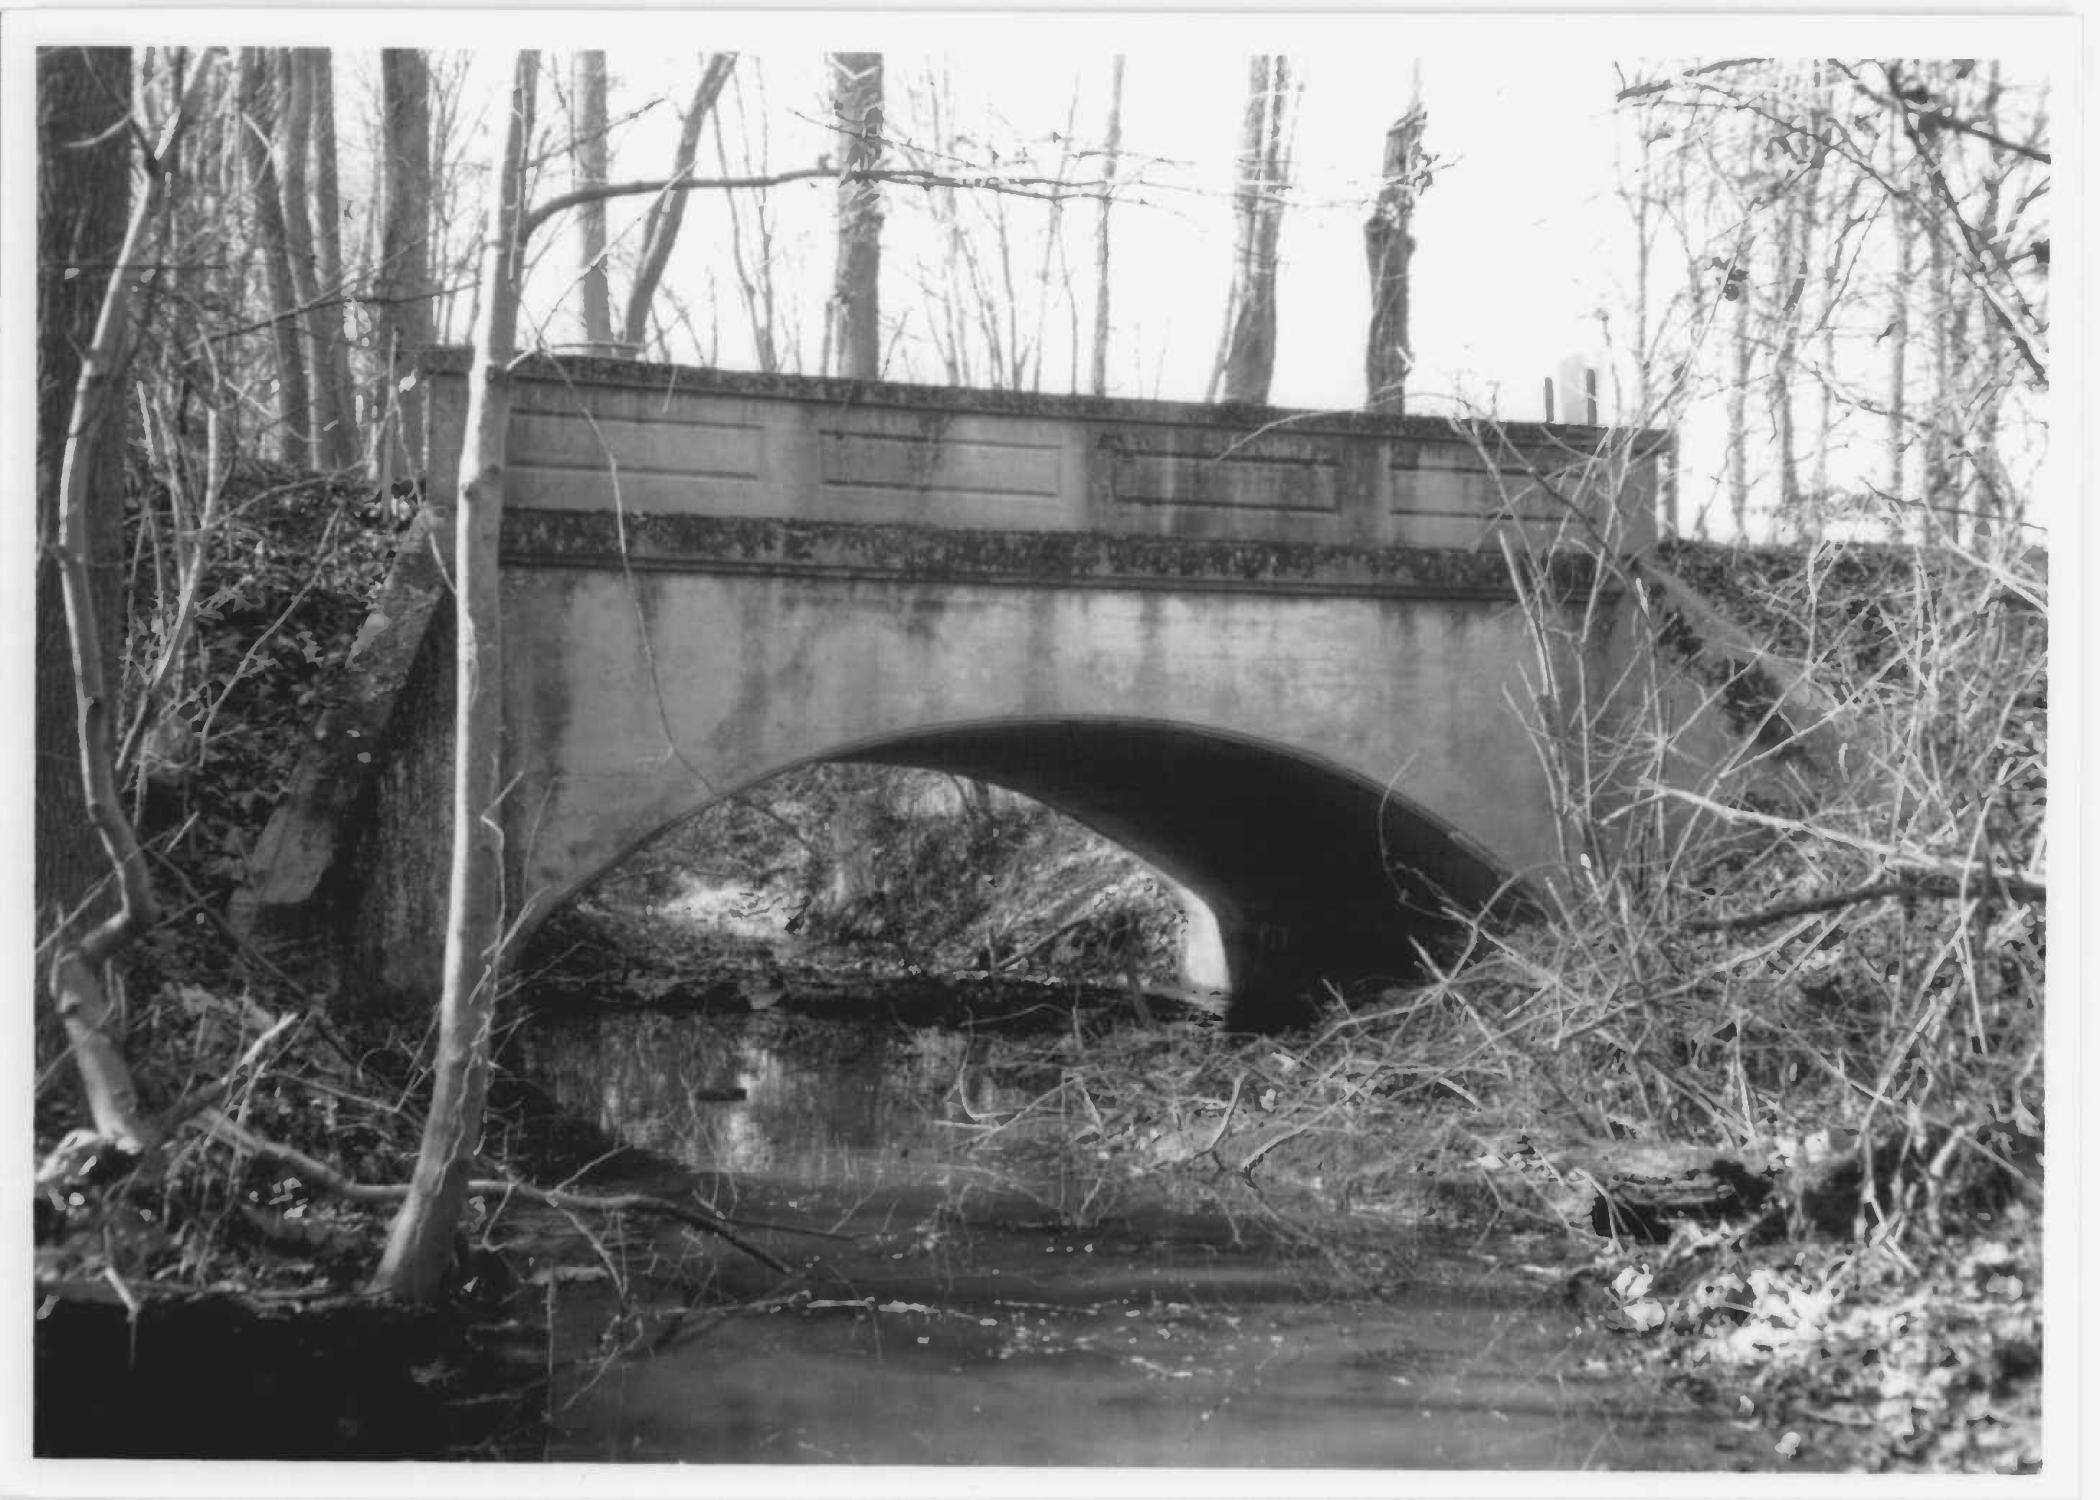
- 1. CAR-301
- 2. CO-20, TUCKAHOE ROAD OVER TRIBUTARY
- 3. CAROLINE COUNTY, MD
- 4. WIALLACE MONTGOMIERY
- 5, 12 97
- 4. MD SHPO
- 7. ELEVATION LOOKING DOWNSTREAM
 - 8 2 OF 4

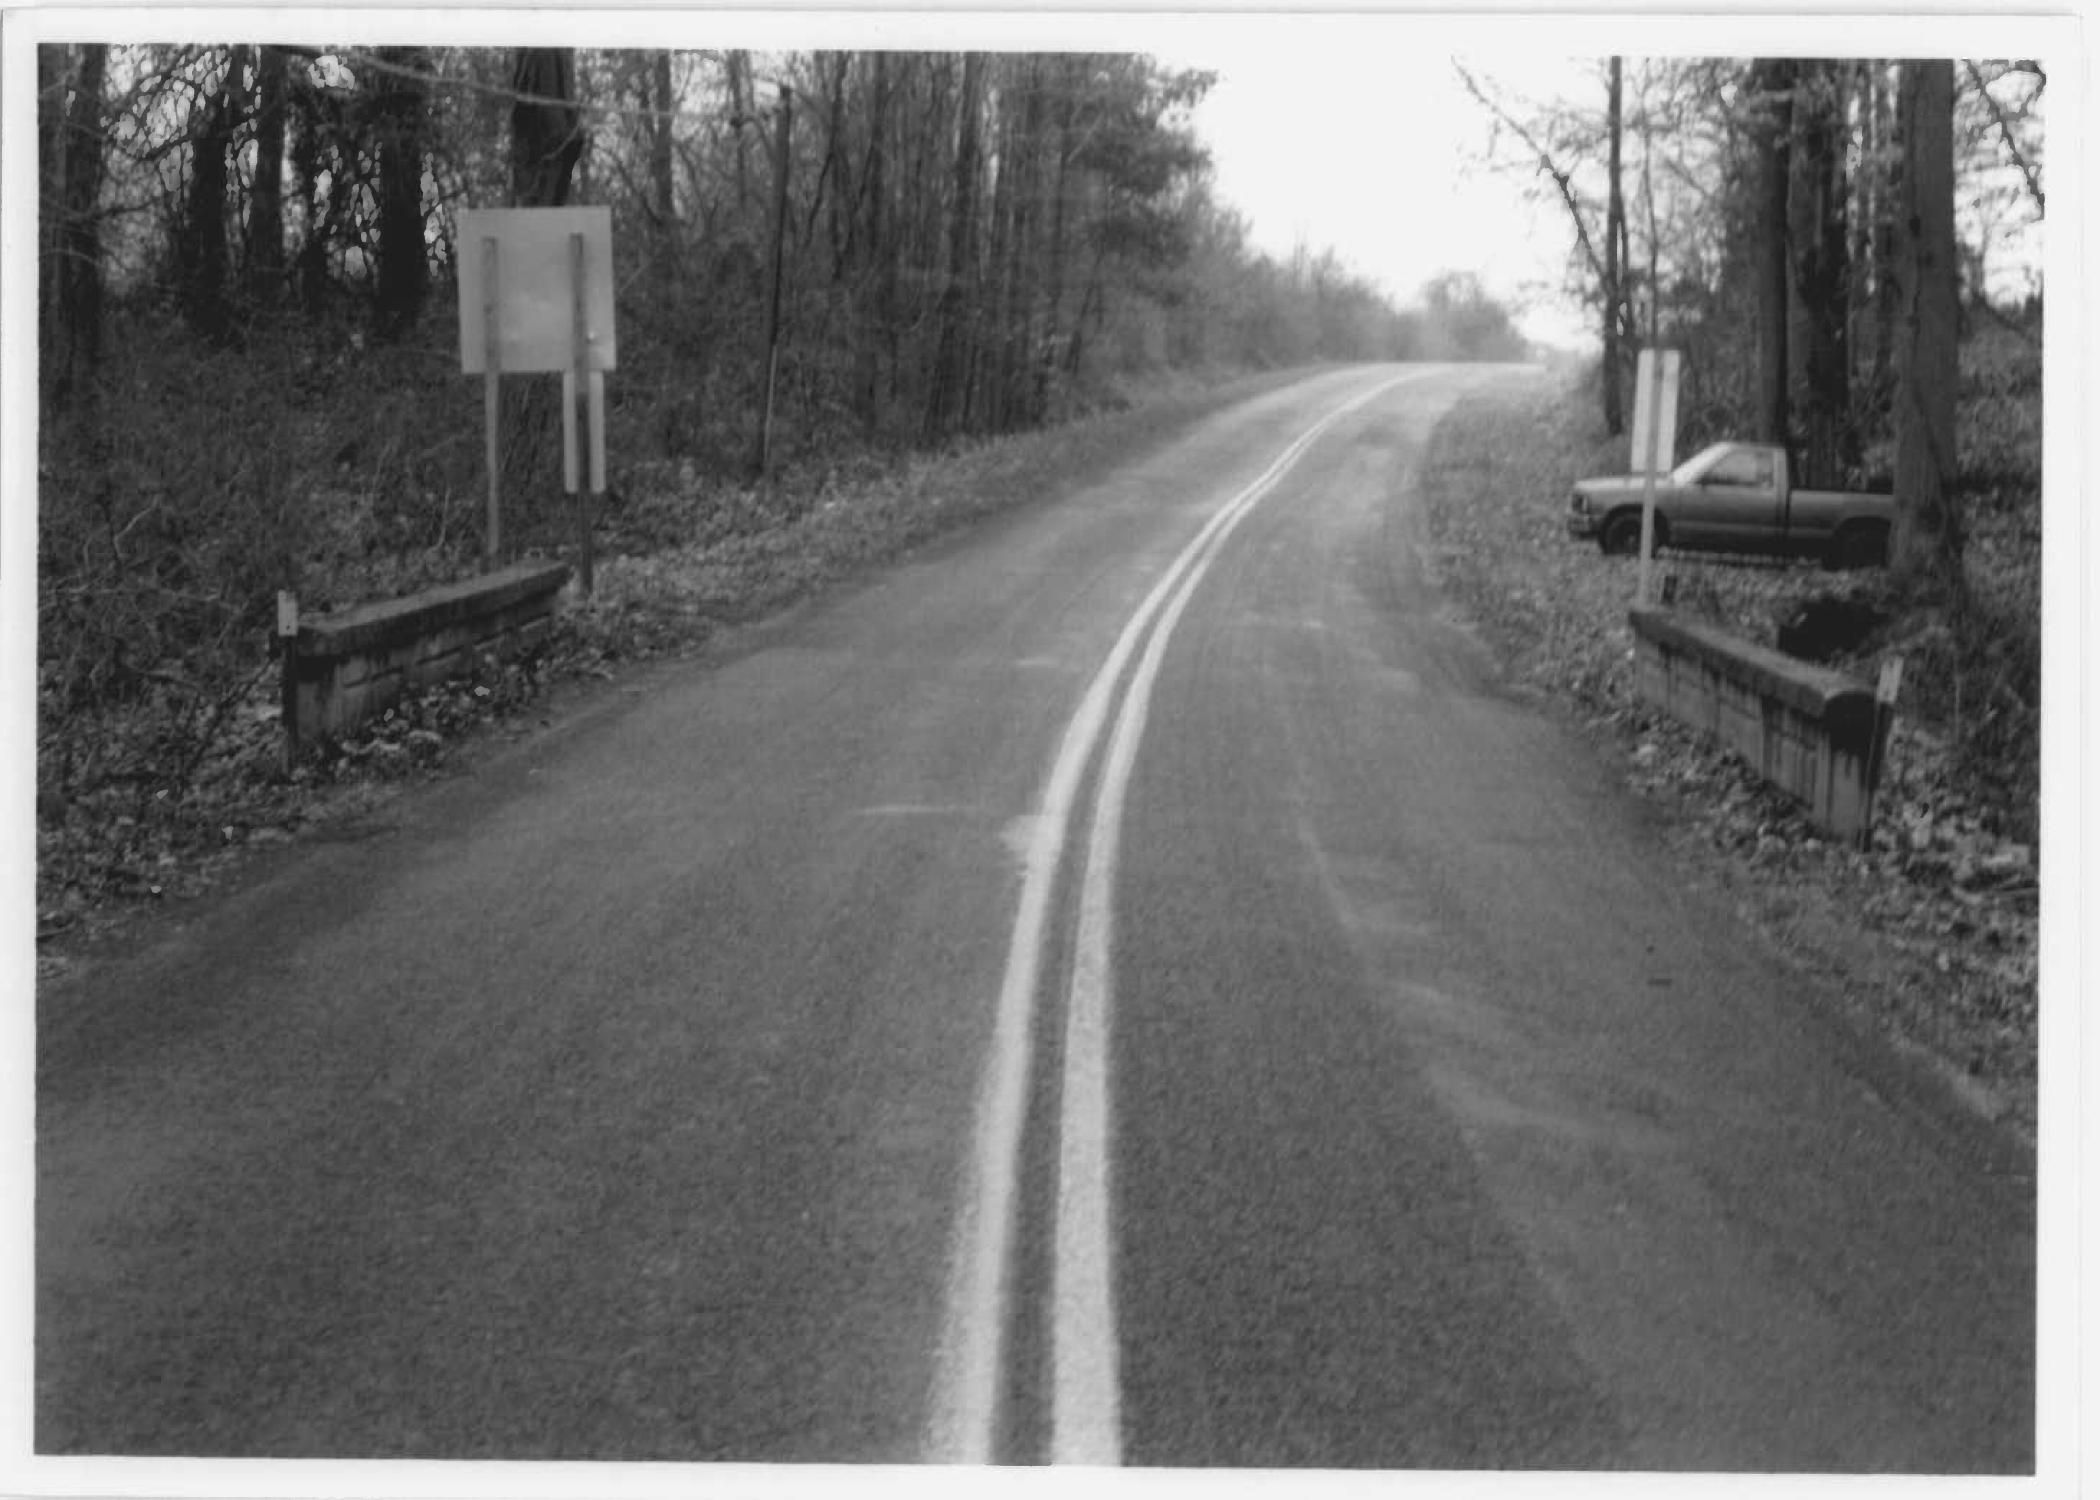
8.3 OF 4

7. LOOKING SOUTH

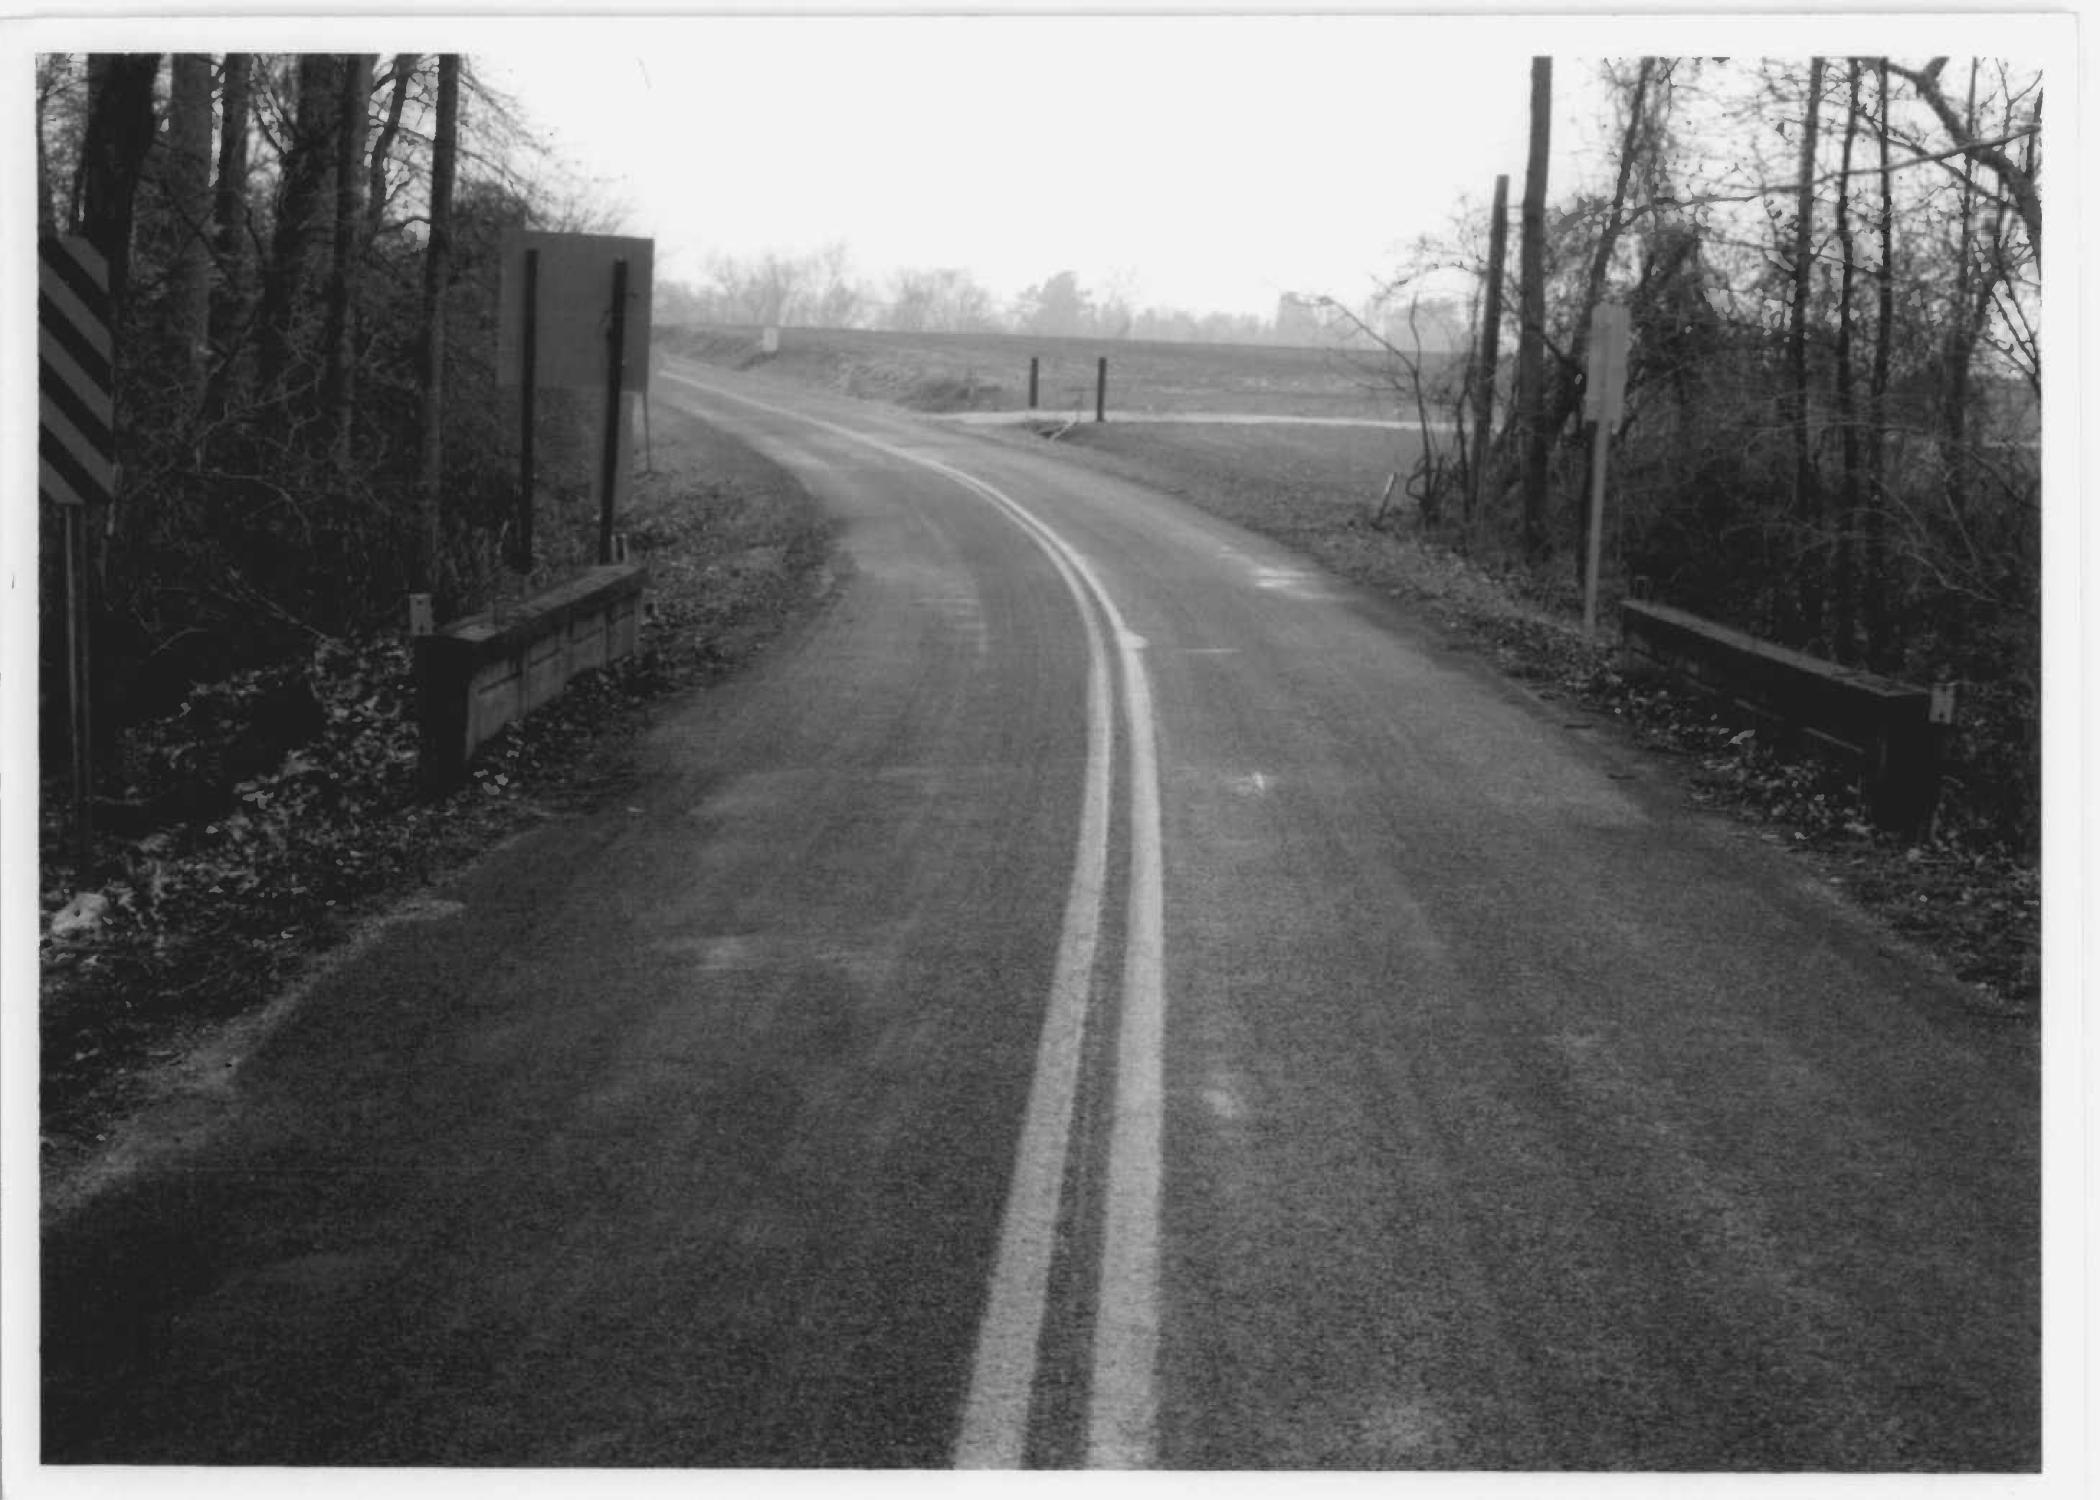
- 1. CAR-301
- 2. CO20, TUCKAHOE ROAD OVER TRIBUTARY TO TUCKAHOE CREEK
- 3. CAROLINE COUNTY
- 4. WALLACE, MONTGOMERY & ASSOC.
- 5, 12/97
- 6. MD SHPO
- 7. LOOKING NORTH
- 8.4 OF 4
